CASE HISTORY OF A REACTIVATION OF A LANDSLIDE DUE TO IRRIGATION ON UNSATURATED SOIL

Kuo-Chieh Chao¹, Daniel D. Overton¹ & John D. Nelson^{1,2}

¹) Tetra Tech, Inc., USA

Abstract: An engineering investigation was conducted to determine mitigation methods for stabilizing an ancient landslide in Colorado, USA. A 0.71-km² golf course was constructed in 1973 on the ancient landslide, which was located in a semi-arid environment along the Front Range of the Rocky Mountains. As a result of the irrigation of the golf course, the landslide was reactivated in 1993, and additional movement occurred after a period of high precipitation in 1995. Seepage analyses were conducted to simulate long-term ground water conditions at the golf course. The results of the seepage analyses indicated that the increased infiltration rate, over the more than 20 year presence of the golf course, caused the increase in ground water elevations responsible for the reaction of the landslide. Slope stability analyses were conducted to simulate progressive slope movements observed in the field. This paper discusses the observations of the slope movement, the analyses that were conducted, and proposed remediation me

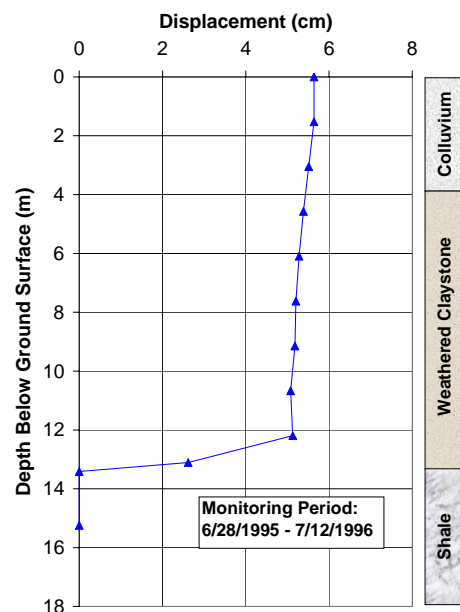
Figure 2. Displacement vs. Depth Below Ground Surface for Inclinometer INC-8.

Inclinometers INC 5 and INC 7 were monitored through August 1996. Inclinometer INC 8 was monitored through July 1996. An example of the slope movements obtained from Inclinometer INC-8 is shown in Figure 2. The surface movement shown in Figure 2 for INC 8 is approximately 5.6 cm and indicates that the slope movement occurred at the interface between the shale and the weathered claystone.

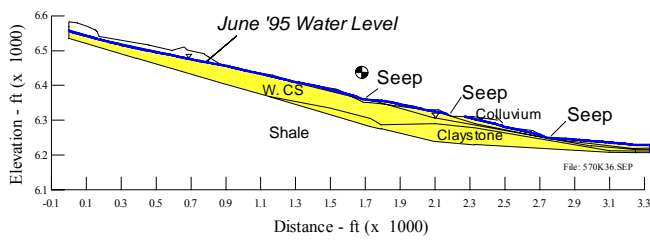
Figure 3. Steady-State Seepage Analysis - Model Calibration.

The predicted phreatic surface computed by SEEP/W for cross section K-K' with an infiltration rate of 2.5 cm/month is shown in Figure 3 as shaded areas, together with the June 1995 water level data obtained from the piezometers. The infiltration rate of 2.5 cm/month was obtained from our water balance analysis (SMI, 1997). Due to good matches between the computed piezometric surface and the field-measured water levels for cross sections K-K' and L-L', confidence can be placed in the seepage analysis models.

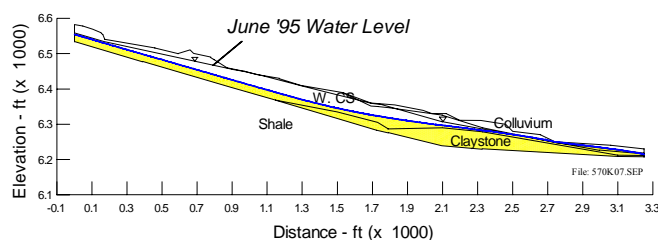
Figure 4. Steady-State Seepage Analysis – Historic Rise of Water Levels – Without Infiltration.

construction of the golf course to the present was modelled. The initial condition of the phreatic surface before construction was determined by modelling the site with zero net infiltration. The predicted phreatic surface for cross section K-K' is presented in Figure 4. This figure indicates that the pre-construction water level was significantly lower than it is at the present time. Stability analysis results show that the slope with the pre-construction phreatic surface was stable.

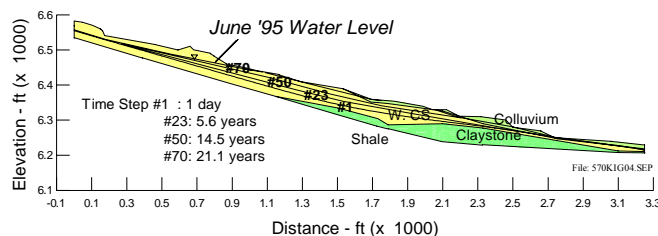
Figure 5. Transient Seepage Analysis - Historic Rise of Water Levels – With Infiltration.

The transient phreatic surface was modelled using an infiltration rate of 2.5 cm/month on the playing areas. Figure 5 shows the resulting rise of the phreatic surface at different time stages after the irrigation began at the golf course. Figure 5 indicates that the modelled phreatic surface took approximately 21 years to rise to levels matching the June 1995 field data. The time period for the rise of the phreatic surface to the present location closely matches the length of time since construction of the golf course.

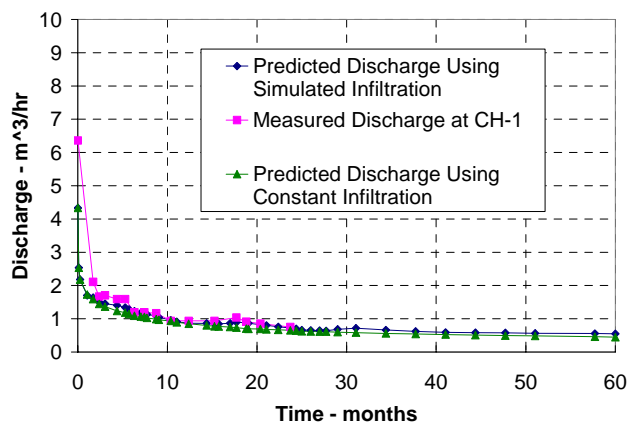
Figure 6. Plot of Predicted and Measured Discharge Rates.

The modelled discharge was compared to measured drain flow rates from Drains CH-1 and DR-1, which are located in areas with similar permeabilities. The discharge at the simulated horizontal drain are plotted with respect to time in Figure 6 for permeability of 2.5×10^{-5} cm/sec. The model fits the measured data well and predicts the actual fluctuations in discharge that follow major precipitation events.

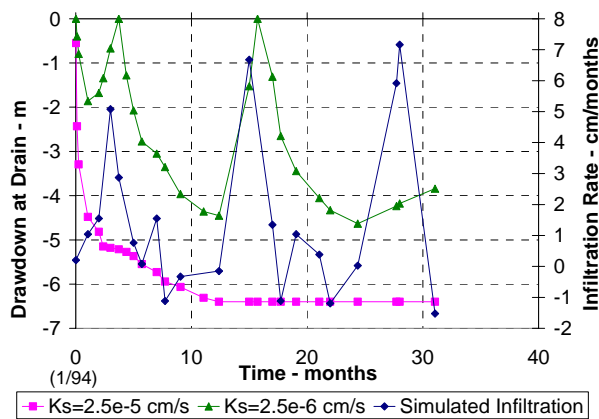
Figure 7. Plot of Drawdown at Horizontal Drain.

Figure 7 shows the predicted effect of hydraulic conductivity on the drawdown at the drains for the observed variation in precipitation. It can be seen that in the soil with a permeability of 2.5×10^{-5} cm/sec the drain is effective in maintaining a low phreatic surface, whereas in the soil with a permeability of 2.5×10^{-6} cm/sec the drain is not effective in lowering the phreatic line after large precipitation events. The horizontal drain will function well in soil with a permeability of approximately 2.5×10^{-5} cm/sec or higher, but is ineffective in soils with permeability values lower than that.

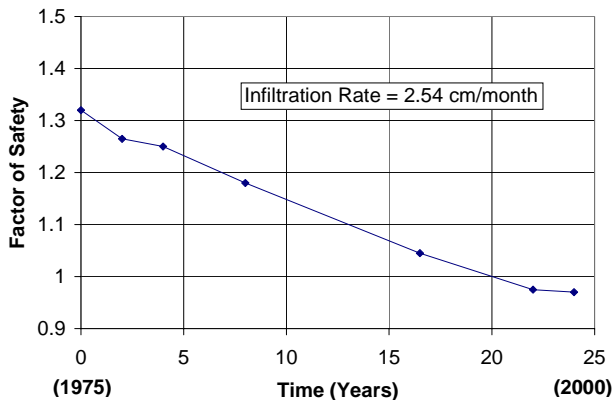
Figure 8. Factor of Safety vs. Time for Cross Section K-K' – Effect of Irrigation

Figure 8 shows the steady decrease in factor of safety over time for an infiltration rate of 2.5 cm/month specified on the playing areas beginning in 1975 (beginning of golf course irrigation) for cross section K-K'. This figure indicates that the factor of safety remained greater than 1.0 until approximately 20 years had elapsed, which occurred in approximately 1995.

The proposed dewatering systems include dewatering drain that are intended to lower the ground water table, and interceptor drains that are intended to gather and divert surface water and to collect shallow ground water. Our analyses indicate that the long-term factor of safety of 1.3 or higher can be reached by constructing the proposed dewatering system.
