## PROJECT EXAMPLES

### WATER MANAGEMENT

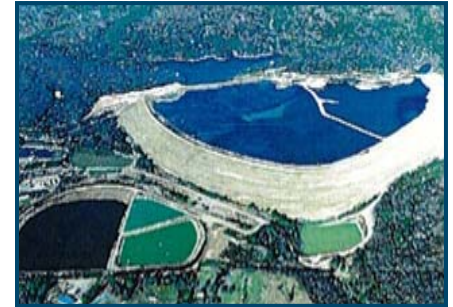
#### MINERS LAKE DAM

In order to remove a restriction placed by the Colorado State Engineer's Office at Miners Lake Dam, Engineering Analytics, Inc. (EA) staff designed remediation to improve the stability of the downstream slope by designing a 3H:1V (horizontal:vertical) downstream buttress, designing erosion protection on the upstream face, and designing a replacement of the outlet works of the dam. EA staff performed the seepage and stability analyses in conjunction with these improvements for review by the State Engineer's Office.

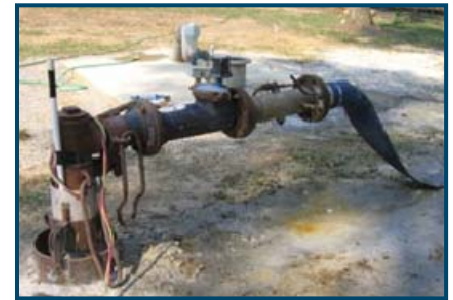
#### SPRING WATER DEVELOPMENT AND PERMITTING

Engineering Analytics staff developed, permitted designed and supervised construction of five large-diameter water supply wells at 3 springs to support production of bottled spring water. The turnkey projects involved location of potential sites, hydrologic testing (drill stem and pumping tests), water quality analysis, permitting of sources, and design and construction of 8" to 20" stainless steel production wells. Because FDA regulations do not permit treatment, wells had to generate pristine "spring" water that could be bottled as is.

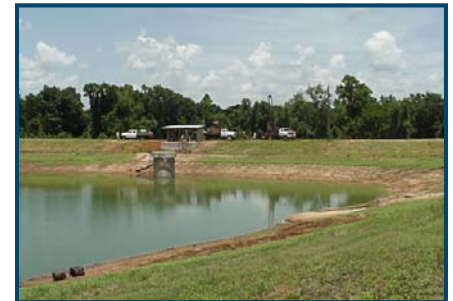
#### STRATCOR DAM

Engineering Analytics staff designed and provided construction services for the reclamation and raise of a 125-foot-high dam near Hot Springs, Arkansas. The project involved laying back the downstream face of the dam to a prescribed angle and concurrently raising and improving the dam for future operations. Work included geotechnical characterization of the earthfill material, design of the dam raise, development of the reclamation plan, and construction management.
