CASE HISTORY OF A REACTIVATION OF A LANDSLIDE DUE TO IRRIGATION ON UNSATURATED SOIL

Kuo-Chieh Chao¹, Daniel D. Overton¹ & John D. Nelson^{1,2}

¹) Tetra Tech, Inc., USA

Abstract: An engineering investigation was conducted to determine mitigation methods for stabilizing an ancient landslide in Colorado, USA. A 0.71-km² golf course was constructed in 1973 on the ancient landslide, which was located in a semi-arid environment along the Front Range of the Rocky Mountains. As a result of the irrigation of the golf course, the landslide was reactivated in 1993, and additional movement occurred after a period of high precipitation in 1995. Seepage analyses were conducted to simulate long-term ground water conditions at the golf course. The results of the seepage analyses indicated that the increased infiltration rate, over the more than 20 year presence of the golf course, caused the increase in ground water elevations responsible for the reaction of the landslide. Slope stability analyses were conducted to simulate progressive slope movements observed in the field. This paper discusses the observations of the slope movement, the analyses that were conducted, and proposed remediation me

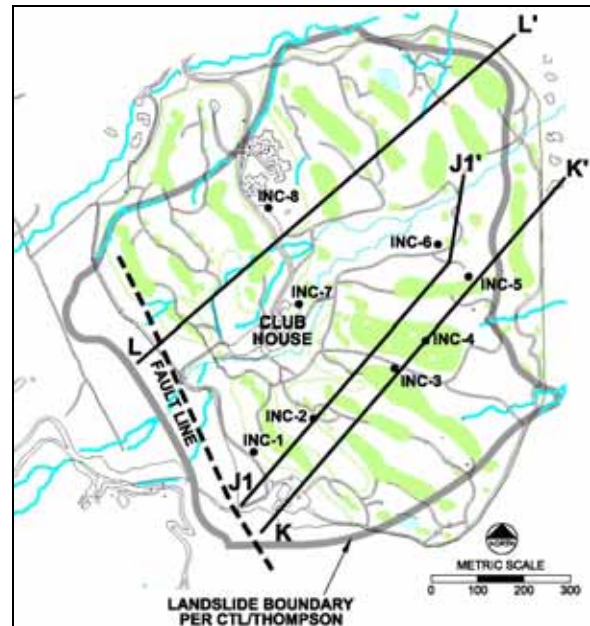
fairways and greens, constructing a club house, constructing a maintenance building, constructing golf cart paths and other hard scaping, installing drainage features and installing an irrigation system. Figure 1 shows the plan view of the golf course.

Figure 1. Plan View of the Golf Course and Locations of Cross Sections K-K', L-L', and J1-J1'.
